DEPARTMENT OF TRANSPORTATION

Office of Structural Materials

Contract #: 04-0120F4Cty: SF/ALA Rte: 80 PM: 13.2/13.9File #: 69.28**WELDING INSPECTION REPORT****Resident Engineer:**Siegenthaler, Peter**Address:** 333 Burma Road**City:** Oakland, CA 94607**Report No:** WIR-022064**Date Inspected:** 16-Dec-2010**Project Name:** SAS Superstructure**OSM Arrival Time:** 700**Prime Contractor:** American Bridge/Fluor Enterprises, a JV**OSM Departure Time:** 1900**Contractor:** Zhenhua Port Machinery Company, Ltd (ZPMC), Changxing Island **Location:** Shanghai, China**CWI Name:** Qiu Wen.**CWI Present:** Yes No**Inspected CWI report:** Yes No N/A**Rod Oven in Use:** Yes No N/A**Electrode to specification:** Yes No N/A**Weld Procedures Followed:** Yes No N/A**Qualified Welders:** Yes No N/A**Verified Joint Fit-up:** Yes No N/A**Approved Drawings:** Yes No N/A**Approved WPS:** Yes No N/A**Delayed / Cancelled:** Yes No N/A**Bridge No:** 34-0006**Component:** OBG components.**Summary of Items Observed:**

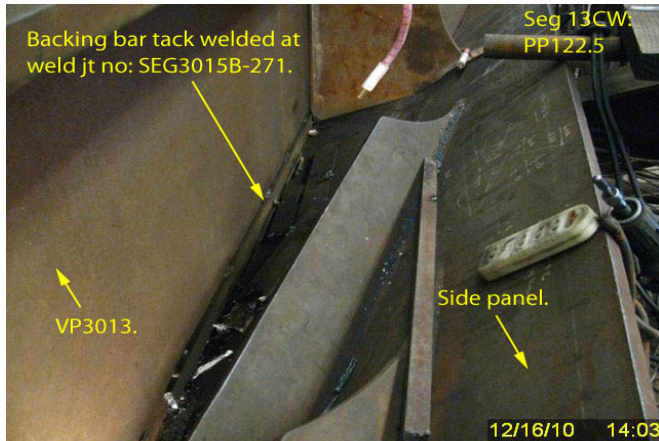
It was also observed that a backing bar was tack welded with VP3013 at PP121.5 to 122, due to excess of root gap. See attached photo for further details.

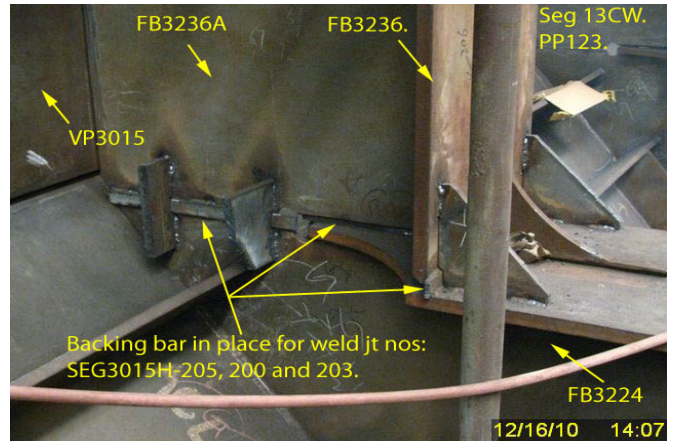
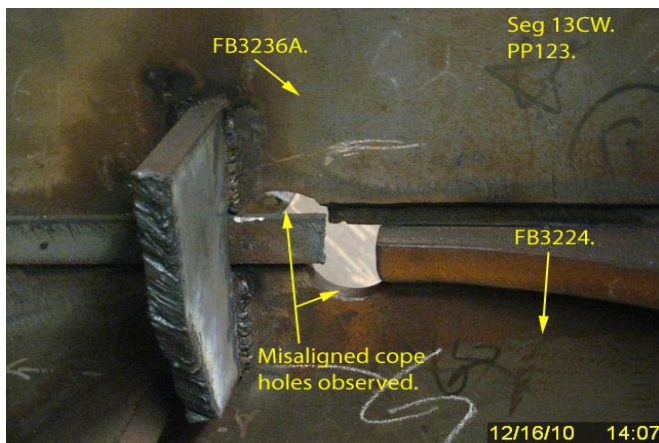
During random inprocess visual inspection, this QA inspector observed that the cope holes of FB3236 and FB3224 are mis-aligned by approx 30mm. Also the root gap at weld joint nos: SEG3015H-205, 200 and 203 was observed to be approximately 15mm. Backing bar was seen to be tack welded to these welds. This QA Inspector discussed this issue with ZPMC QC identified as Sun Tian Ling to weld this joint after Engineers approval for this excess root gap. See attached photos for further details.

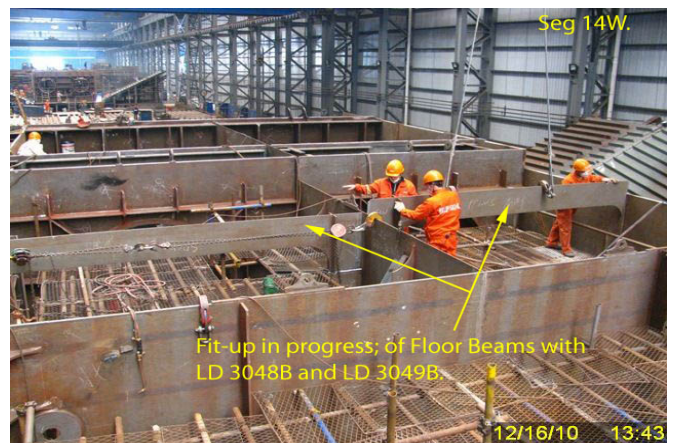
This QA Inspector observed ZPMC personnel performing fit-up of FB3238, FB3340, FB3332, FB3323 and FB3349 with Longitudinal Diaphragm (LD) 3049B and LD 3048B (from PP 126.5 to PP128). See attached photo for further details.
